# Lake Eden 2023 Pre-Treatment Eurasian Water Milfoil Inventory

June 19, 2023

**ARROWWOOD ENVIRONMENTAL**  
950 BERT WHITE ROAD  
HUNTINGTON, VT 05462  
(802) 434-7276 FAX: (802) 329-2259

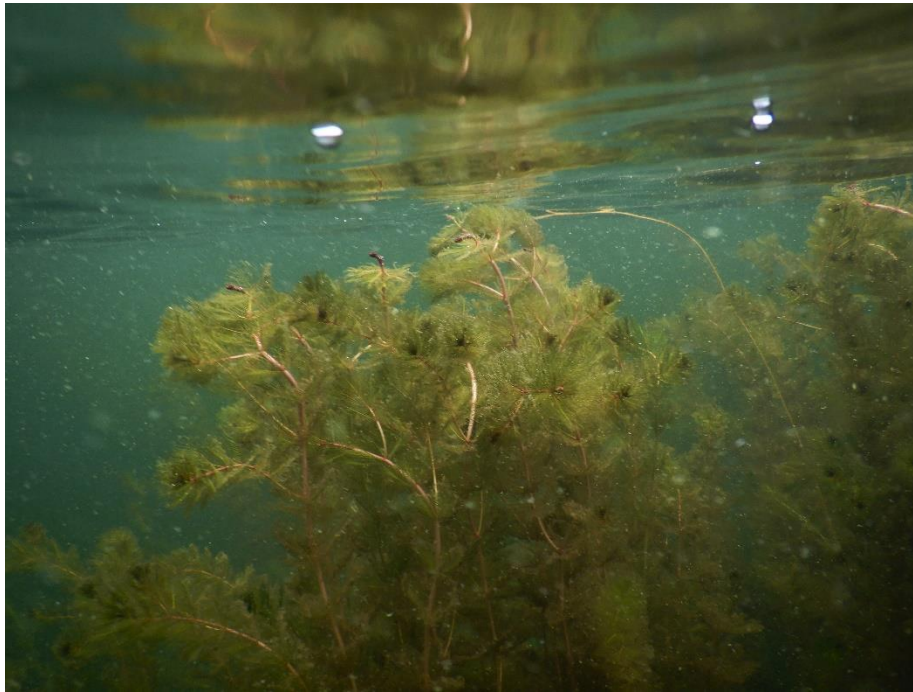
EWM near Boy Scout  
camp  
6/15/2023

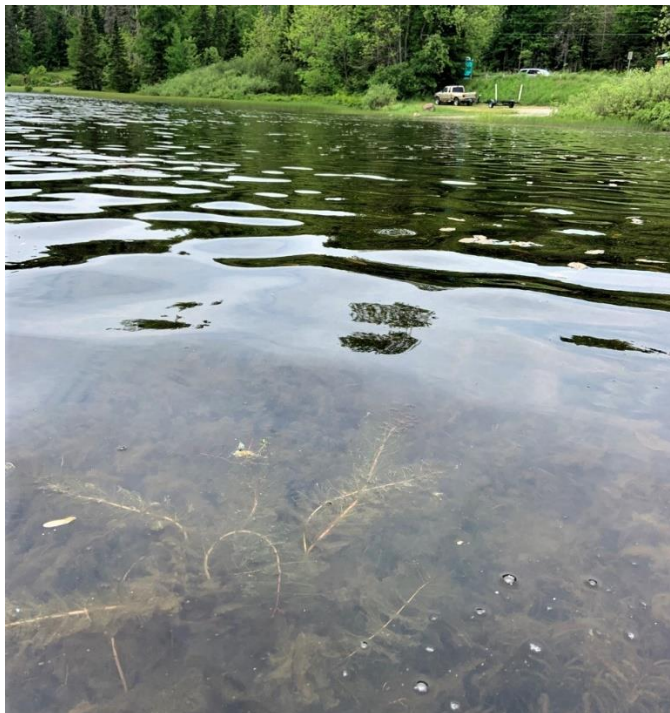
EWM near public boat  
launch  
6/12/2023

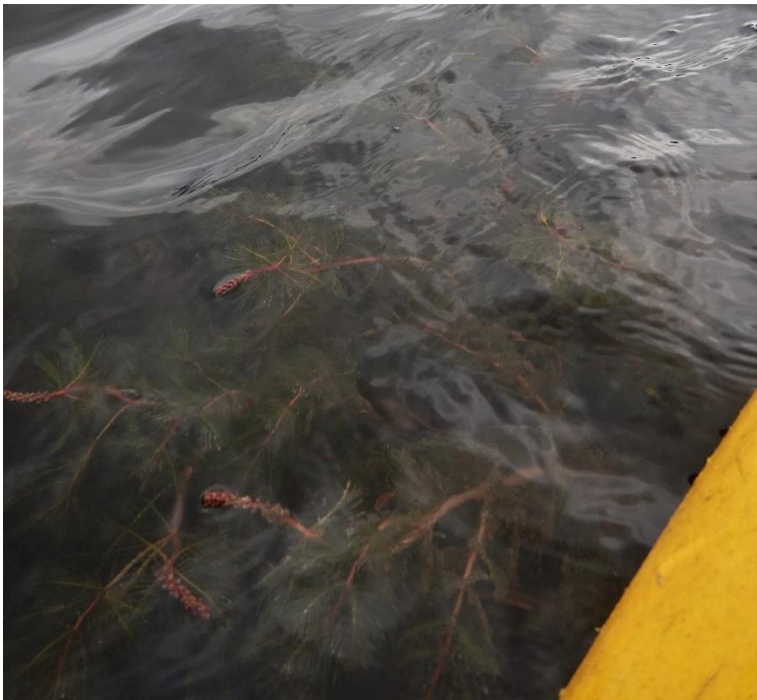
EWM flowering near  
public beach  
6/15/2023

Every effort was made to detect all of the EWM in the lake. However, due to the size of the lake and the limited underwater visibility, some EWM may have been missed. The area in the vicinity of the public beach, in particular, is quite large and should be scanned by the DASH crew for EWM occurrences that may have been missed by the current inventory. As shown in the map in Appendix 2, no EWM plants were documented in the southwestern end of the lake. However, 12 fragments of EWM were found (and removed) floating in this area. Given wind and water currents, this area should be monitored later in the season for any EWM that may become established from fragments.
