# Watershed Action Plan

## Lake Eden Watershed

### Eden, Vermont

December 20, 2019

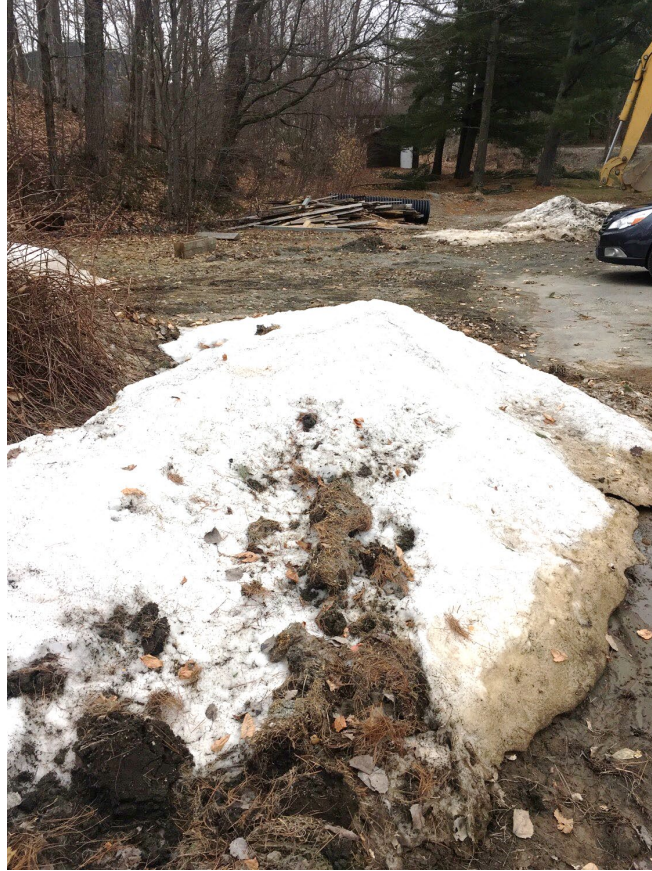
**Figure 6:** Part of a large paved parking lot at the Boy Scout Camp.

parking area at the Boy Scout Camp. Total impervious area at the Camp exceeds 1 acre, and significant drainage problems around the facility have been noted by Camp staff. The location of snow storage for the parking lot may be contributing extra runoff to the channel.

Five (5) of the highest priority projects were selected for the development of 30% concept designs (Appendix F). Concept designs include:

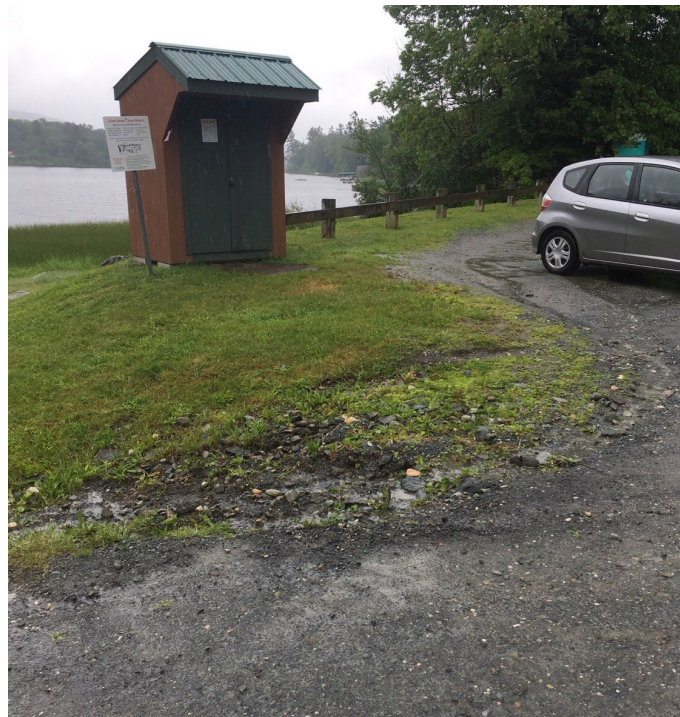
1. **Project SW-4: Vermont Fish and Wildlife Boat Launch** – Concentrated runoff from Route 100 is causing rill erosion near the cross-culvert inlet conveying water to the adjacent wetland, and directly to the lake. The recent addition of water bars has helped intercept flow from Route 100, but opportunities remain to improve infiltration and sediment retention on-site. The sediment load at the site may be exacerbated by accumulation of gravel in the winter from plowing.
2. **Project SW-5: Boy Scout Camp Parking Lot** – An eroded channel and gully where the channel enters the stream is forming from stormwater runoff concentrated along the western side of the

**Figure 7:** Erosion at the VT Fish and Wildlife Boat access observed during a storm event in June 2019. The concept design for this area (SW-4) describes a BMP that would treat this runoff.
