Application for use of **Pesticides**  
under an **Aquatic Nuisance Control Permit**  
Per 10 V.S.A. Chapter 50, § 1455

Application Number: 4475-ANC

Long Term Eurasian Water Milfoil Management Plan

# LAKE EDEN 2024 AQUATIC MACROPHYTE SURVEY

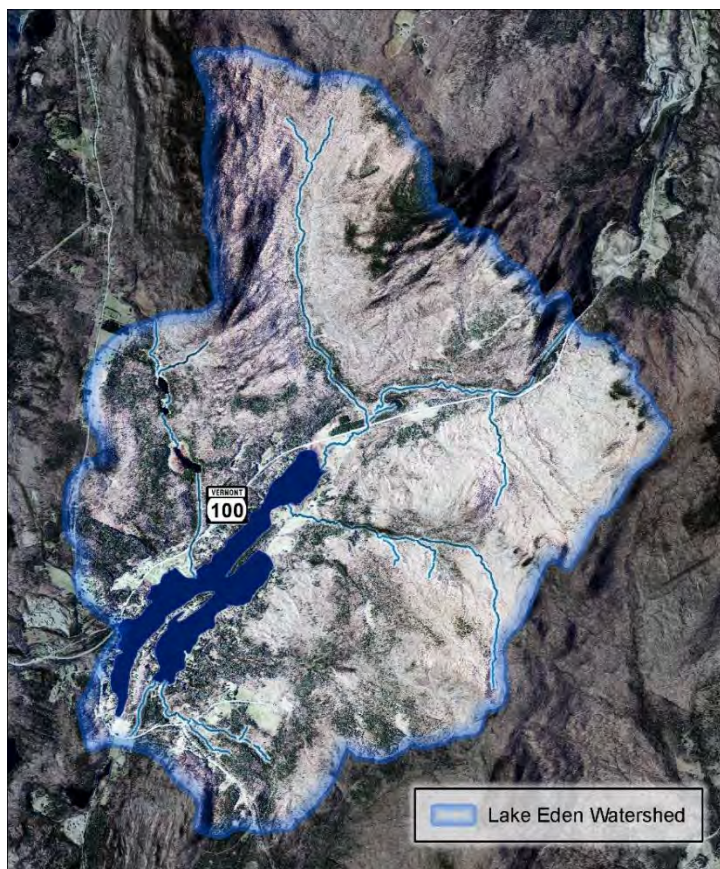
FIGURE 1. LAKE EDEN WATERSHED

The Lake Eden system is underlain by schists and phyllites from the Stowe Formation (Ratcliffe et al. 2011). The underlying bedrock can impact the chemistry of the water, in this case resulting in a moderately alkaline lake. Chemistry and nutrient content of the water is also highly influenced by the nature of the surface water inputs. The nature of these inputs, in turn, are influenced by the land use in the surrounding watershed. Land use in the watershed can therefore have a large impact on water quality in the lake. Land use in the Lake Eden watershed is a mixture of forested lands, agricultural fields, and rural residential development. In their analysis of watershed land use, Vermont

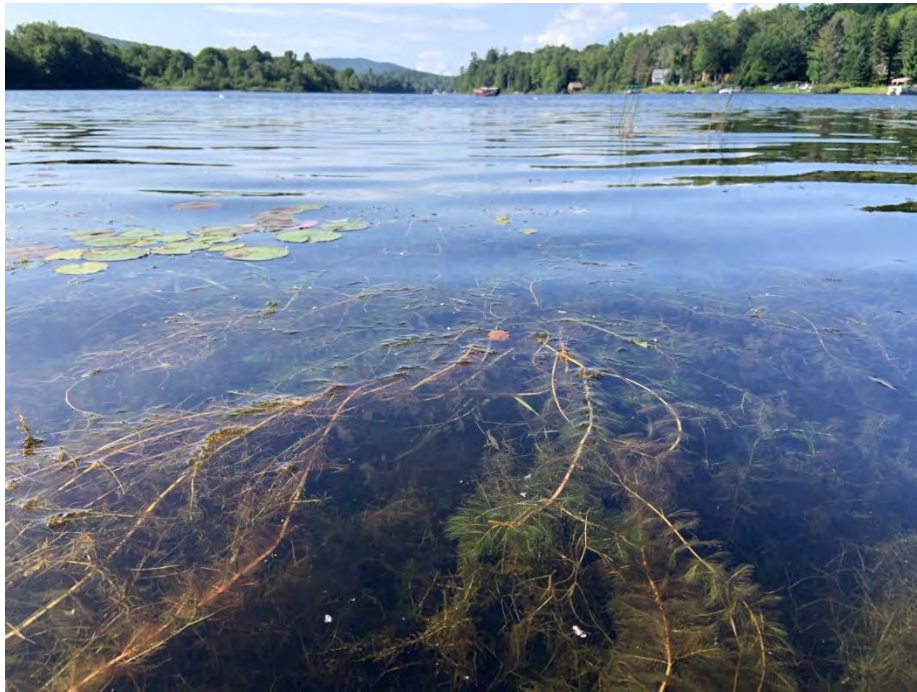
EWM surfacing near the  
boat launch  
8/28/2023

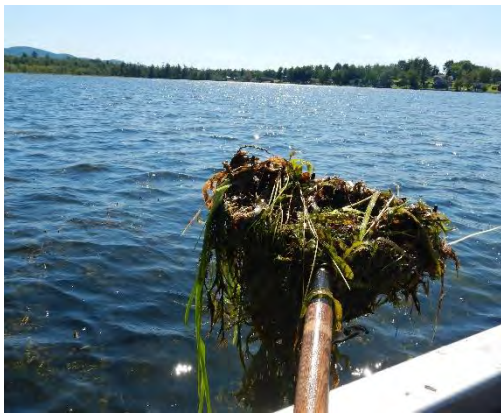
**Figure 1. Aquatic sampling rake**

Percent cover of both submerged and floating aquatic plants was recorded at each grid point using the categories shown in Table 2. Recording percent cover of aquatic plants is a similar metric as the biomass but not dependent on water depth. If submerged vegetation was growing dense enough that it was laying on the surface of the water, it was considered a floating aquatic plant for this metric. If submerged vegetation could not be seen from the boat, this data was left blank.

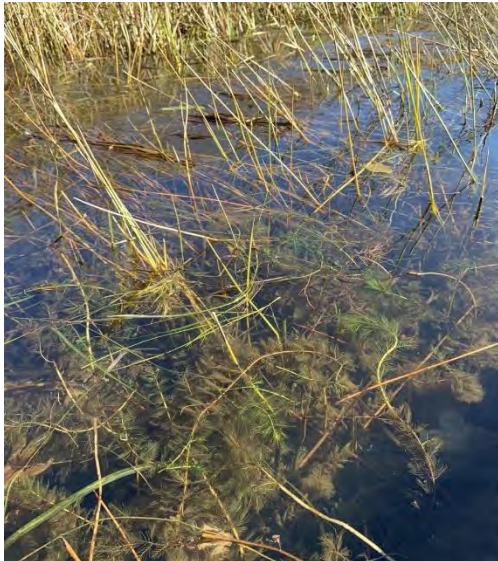
**Figure 3 EWM in Shallow Water Near Boat Launch**

**Boat Launch.** EWM at the Boat Launch site consists of 8 individual plants as well as three areas where EWM was abundant enough to map using percent cover. The largest of these has 1-5%

cover of EWM and sits just on the deeper edge of the Benthic Mats across much of this northern bay. Depth of plants in this area ranges from 4'-12' deep. Two other infestations were mapped on the shallow side of the Benthic Mats: one with sparse EWM cover and one with moderate-dense EWM cover. Both of these exist in very shallow water, generally less than 1' deep. The shallow depths and mucky substrates make these infestations difficult to control.
