# LAKE EDEN 2025 AQUATIC VEGETATION SURVEY REPORT

PREPARED FOR THE LAKE EDEN ASSOCIATION

NOVEMBER 24, 2025

**ARROWWOOD ENVIRONMENTAL**

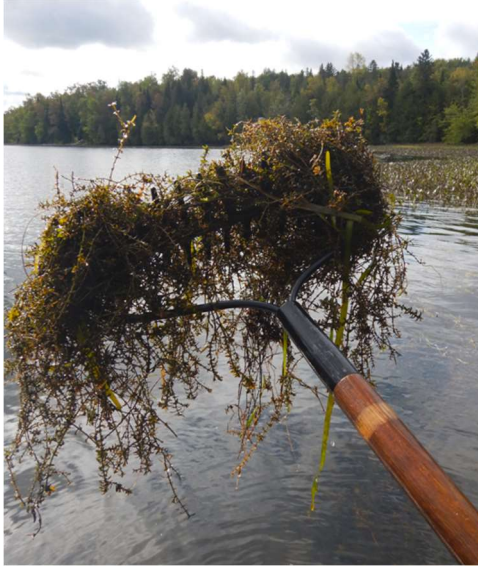
**Figure 1. Aquatic Sampling Rake**

An aquatic survey rake was used to gather the vegetation data at each point location. In waters shallower than 8', a rake on a pole was used to sample

vegetation. In waters deeper than 8', a survey rake attached to a rope was used to sample vegetation. Rake fullness, as outlined in Table 1, was recorded for each sample to obtain information about vegetation density (Hauxwell et al. 2010; Madsen et al. 1996). Each aquatic plant on the rake was identified to species, if possible. Specimens that were difficult to identify in the field were collected and examined under a dissecting scope. Voucher specimens of many species recorded in the lake were collected and stored at either the Arrowwood Herbarium or at the Pringle Herbarium at the University of Vermont. The abundance of each species on the rake was recorded using the categories outlined in Table 1.

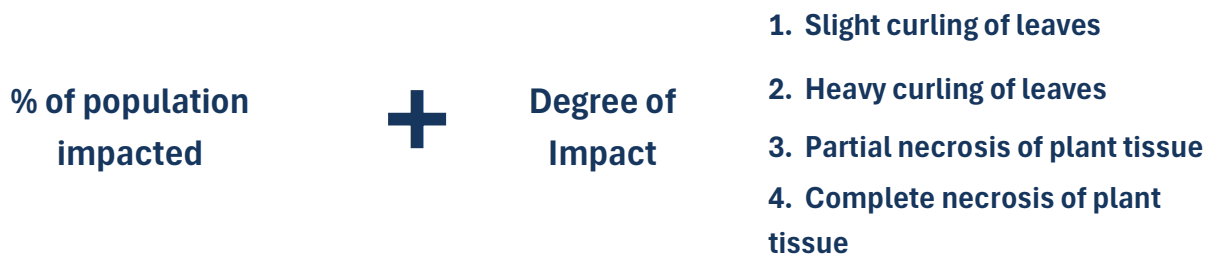
**Figure 2. Non-Target Impact Assessment**

This assessment involves a visual littoral survey of plant impacts throughout the pond with particular focus on areas in the vicinity of the herbicide application. For each impacted species, data is collected on the percentage of the population impacted and the degree of impact on the plants. The degree of impact has been categorized as shown in Figure 2.

The degree of impact on non-target plants can range from non-fatal curling of leaves to complete leaf necrosis and will vary depending on the plant species and degree of exposure to the herbicide. The lesser impact categories (curling of leaves) typically have a minor effect on overall plant survivorship. Complete necrosis of the leaf tissue may or may not lead to plant mortality depending on the species.

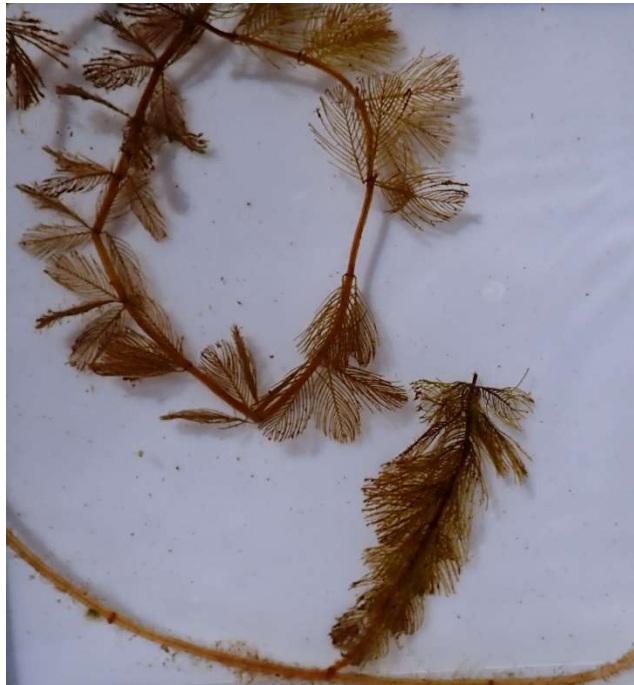
**Figure 3. EWM showing complete necrosis from herbicide treatment**

The data in Table 5 shows that the EWM abundance in Lake Eden decreased substantially after herbicide treatment. No EWM plants were found post-herbicide in the Boat Launch area and only a single EWM plant was found in the Scout Camp area post-treatment. The EWM plants that were documented in the Northwest Quadrant were mostly located southwest of the herbicide treatment area. The herbicide application in the Public Beach area

appears to have been successful; no EWM plants were documented post-herbicide.

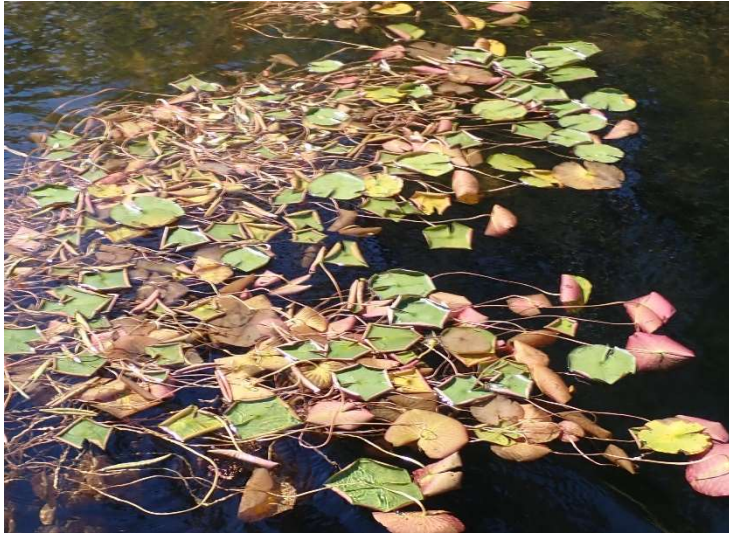
**Boat Launch.** The non-target impacts on water lily (*Nymphaea odorata*) were quite pronounced in the Boat Launch area, where 90% of these plants exhibited complete leaf necrosis. This species has a large storage organ

beneath the sediment and typically produces many leaves; necrosis of some leaves therefore does not typically result in overall plant mortality. However, the level of impact exhibited in the Boat Launch area may have resulted in plant mortality. It is unknown what impact this will have on the population of water lilies in this area.

**Figure 4.** Water lily leaves showing impacts from herbicide
